# Analysis of Right-In, Right-Out Commercial Driveway Safety, Operations and Use of Channelization as Compliance Countermeasure

A Thesis  
Presented to  
the Graduate School of  
Clemson University

In Partial Fulfillment  
of the Requirements for the Degree  
Master of Science  
Civil Engineering

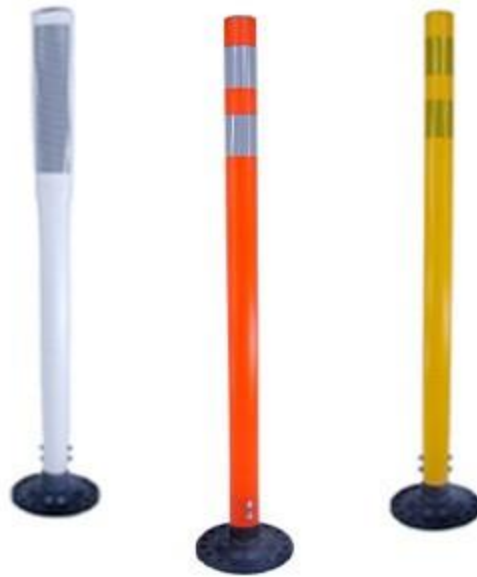
**Figure 2.2: 3 Types of Tubular Markers (source: [www.trafficwks.com](http://www.trafficwks.com))**

Flexible lane delineators/bollards and longitudinal channelizers are commonly used to guide the drivers horizontally and can be effective for speed-reduction or traffic calming (17). These devices when used in conjunction with other speed reducing devices, can reduce injury accidents by 25%. Flexible bollards are cost effective and can withstand vehicle impacts, however, placement needs should not impede with the normal functioning of the traffic. Figure 2.2 shows an example of the common types of flexible delineator posts, namely tubular markers. The flexible delineators are designed to withstand impacts from vehicles by transferring the stress from impact point to the base.

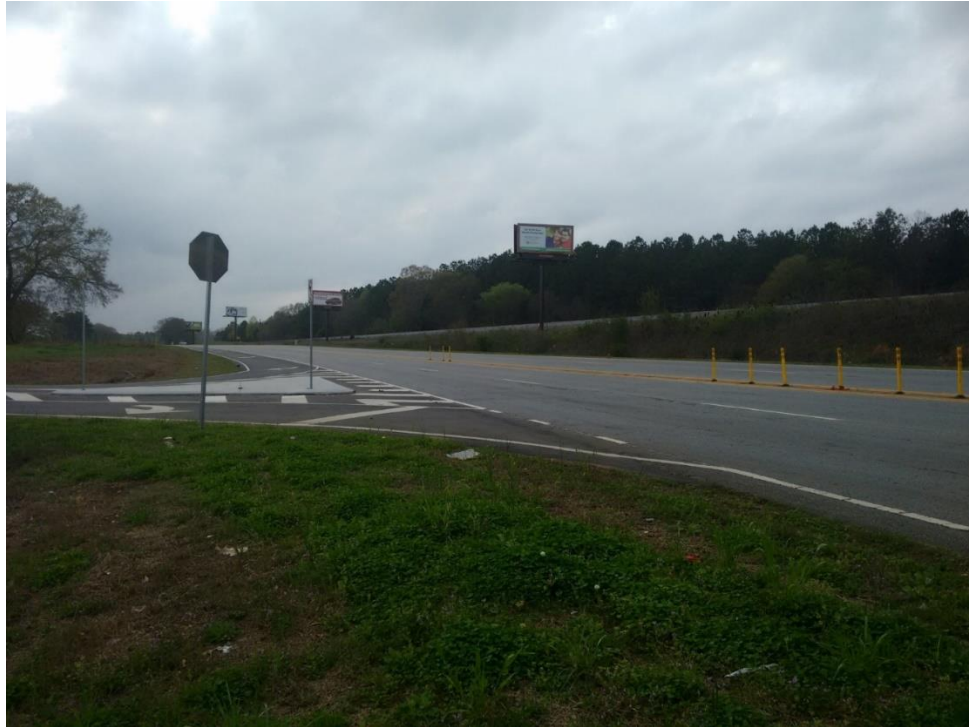
**Figure 2.4: Longitudinal Bollards at New Spring Church, Clemson, SC**

The longitudinal bollards presented in this chapter, even though effective as delineation devices, can be damaged due to vehicle impact or wear out over time. Figure 2.4 shows a location with well-designed isolated RIRO driveway at New Spring Church, supplemented with longitudinal bollards on US 123 in Clemson, SC. It can be observed that the bollards are displaced from their actual position and the large gap thus formed

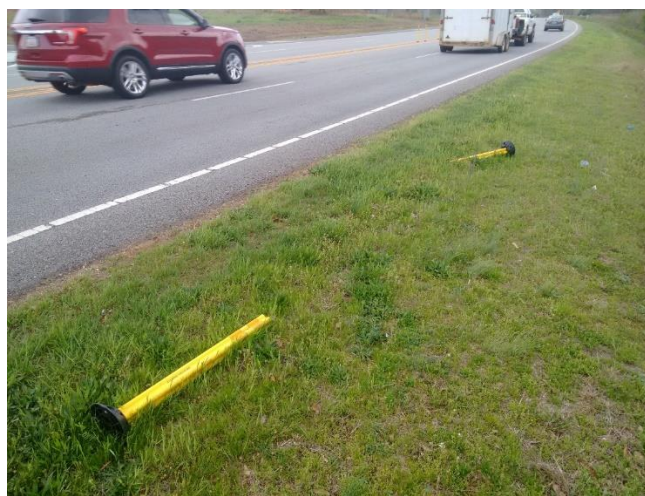
**Figure 2.5: Bollards displaced at New Spring Church, Clemson, SC**

allows the drivers to make left turn maneuvers without much difficulty. This can be seen in Figure 2.5. The images pertain to March 30, 2017.

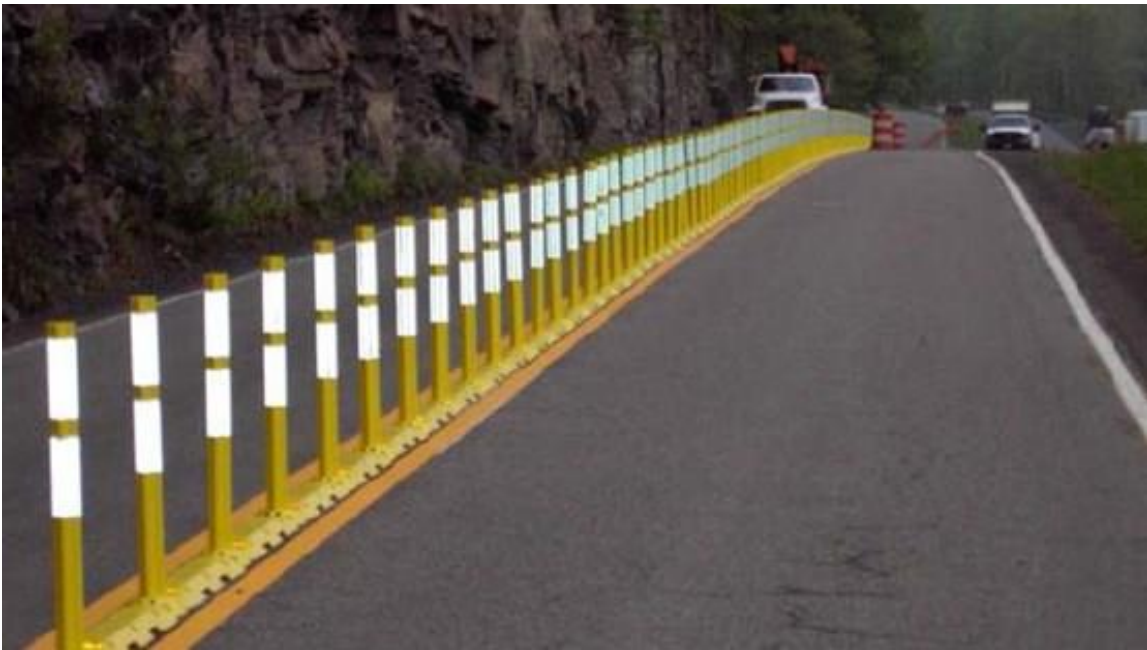
**Figure 2.6: FG 300 Interstate Grade Curb System**

There are several other devices in the market that can provide longitudinal delineation at an isolated RIRO driveway like bollards. They could be more effective in terms of restricting the drivers from making left turn maneuvers at RIRO driveways. Some of the examples are interstate grade curb system, qwick kurb and road quick curb. An interstate grade curb system is depicted in Figure 2.6. An interstate grade curb system provides channelization on interstates, toll-ways and city streets and other functional classes of highways as lane separation devices.

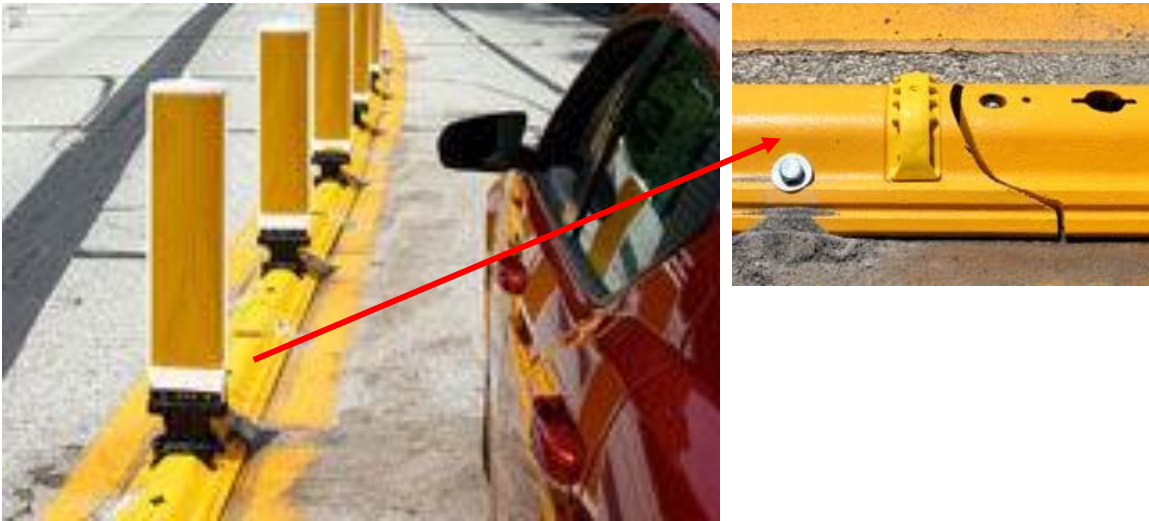
**Figure 2.7: Qwick Kurb System**

Figure 2.7 depicts a qwick kurb system used as a channelization device and provides a raised curb system unlike the longitudinal bollards. Similarly, Figure 2.8 shows road quick curb used to channelize traffic with portable delineation devices.

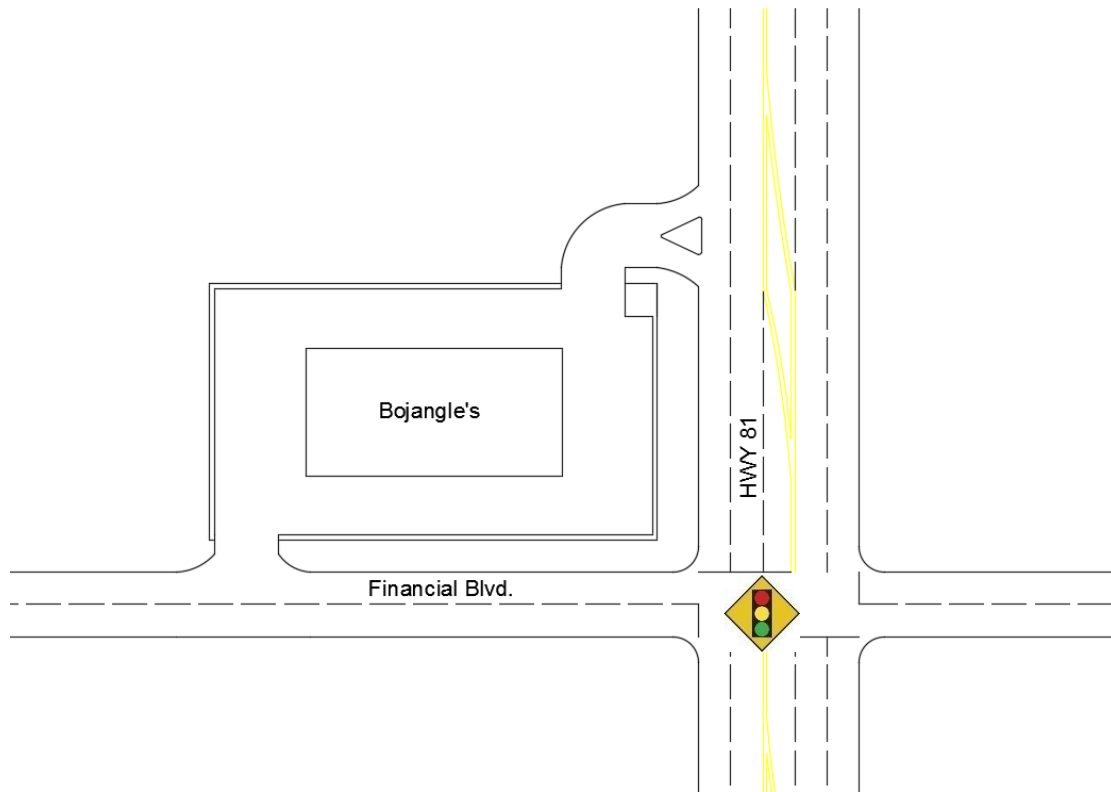
**FIGURE 3.3: Case study site schematic**

**Table 3.2: Driveway Design Specifications Satisfied by the RIRO**

<b>Design Guideline Description</b>	<b>Specification</b>	<b>Provided</b>
Area of Concrete Island (ARMS)	Min. 100 sq. ft	128 sq. ft
Length of each side of Island (ARMS)	Min. 12ft	16'×16'×16'
Offset of the island from edge of the travel way (ARMS)	Min. 4ft	6 ft.
Solid white Stop Bar Width (MUTCD)	12 in. to 24 in.	24 in.
Driveway width (Throat Width)	Min. 28ft	24 ft.
Height of the sign	5ft in rural areas	5 ft.
Lateral offset provided for the sign	Min. 2ft	2 ft.
Lane Width	14ft	14 ft.
Angle of intersection of driveway with the adjacent highway (ARMS)	Min. 70 degrees	90 degrees
Width of dividing pavement marking	4 in. to 6 in.	4 in.
Driveway Length (Throat length)	Min. 40 ft	56 ft

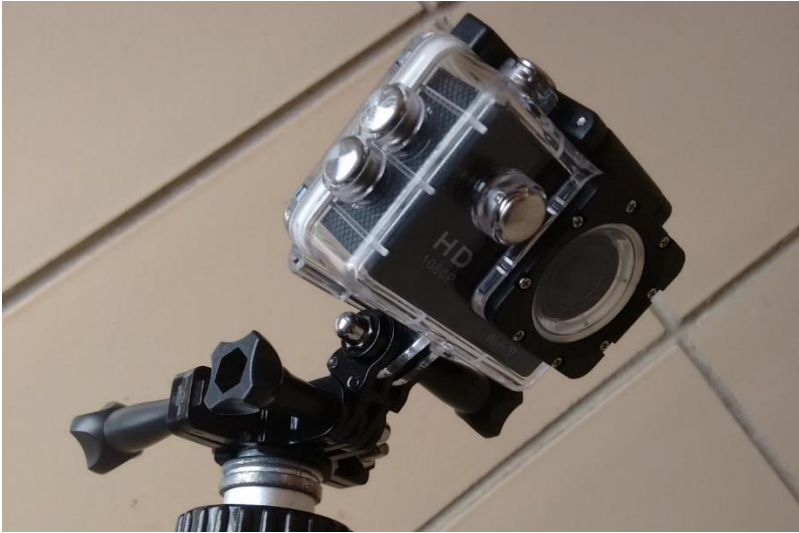
**Figure 3.6: Camera Setup**

A low-cost traffic data collection system was used for collecting the video data. The video from this system was processed manually using JAMAR digital count boards. The key components of the system are the generic all-weather action camera (ANART) and the mounting system. The camera system is a light weight, portable, and environmentally protected setup with sufficient memory and power supply to last for a minimum of 1 1/2 hours (the analysis period for this study is 90 minutes). The camera is enabled with Wi-fi to allow viewing during data collection. This ensured adequate coverage of the driveways. The basic setup for the data collection system at a driveway includes the camera enclosed in a protective case, a telescoping pole, a mounting bracket, battery supply, and memory. Figure 3.6 shows the camera enclosed in a protective case. This camera is mounted on the telescoping pole using the mounting bracket and raised and attached to an existing utility or light pole in the field. The setup is shown in Figure 3.7 and a video image is shown in Figure 3.8. The complete installation usually takes about 5-10 minutes in the field.

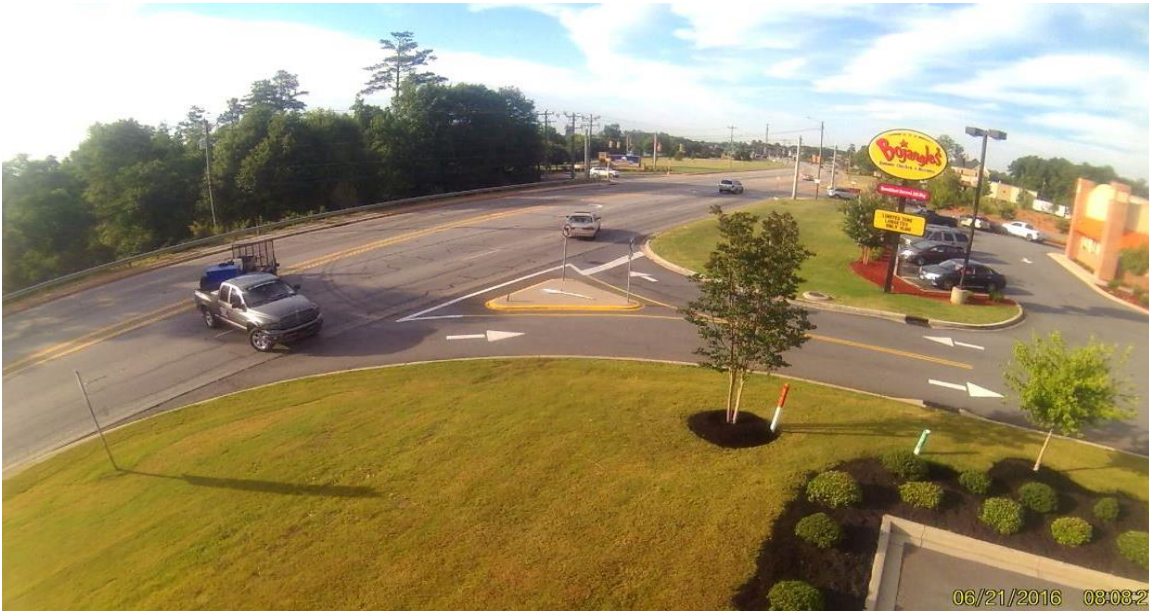
**Figure 3.8: Coverage of Video Data from the ANART cameras**

Driveway data was collected initially in video format so that driver behaviour could be monitored in addition to recording the movements. The video data provided adequate clarity and coverage to observe driver behaviours such as vehicles trying to exit the driveway through a left turn maneuver but gave up due to heavy through traffic on the adjacent highway (State Route 81).

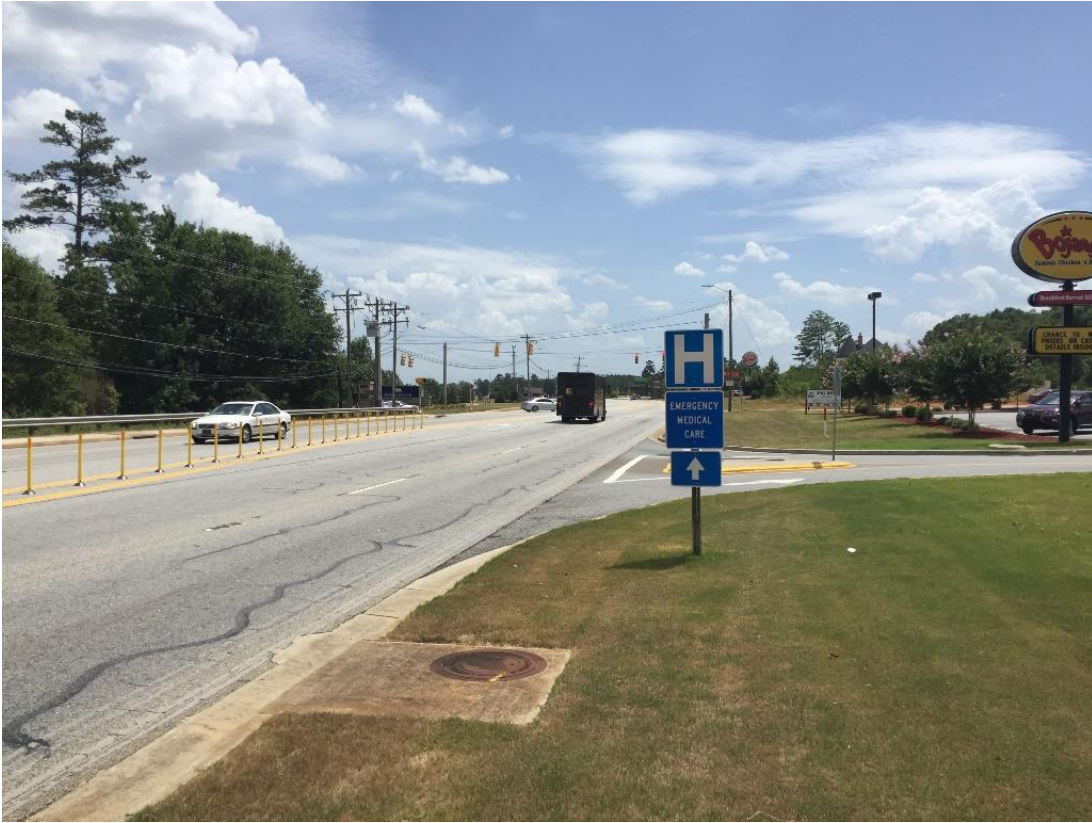
**Figure 3.14: RIRO with bollards installed**

While the volumes indicate that the bollards were effective in reducing illegal left-turns at the RIRO driveway, these maneuvers were not eliminated completely. Some drivers drove the wrong way along SC 81 just after the intersection to bypass the bollards and enter the driveway. Other illegal movements made by drivers include making U-turns across a double-double yellow line (painted median) just beyond the location of the bollards, to access the RIRO driveway. Similarly, some of the drivers exiting the driveway initially made a right turn followed by a U-turn just after the bollards instead of going all the way to the intersection. Figure 3.14 shows the RIRO driveway after bollard installation.

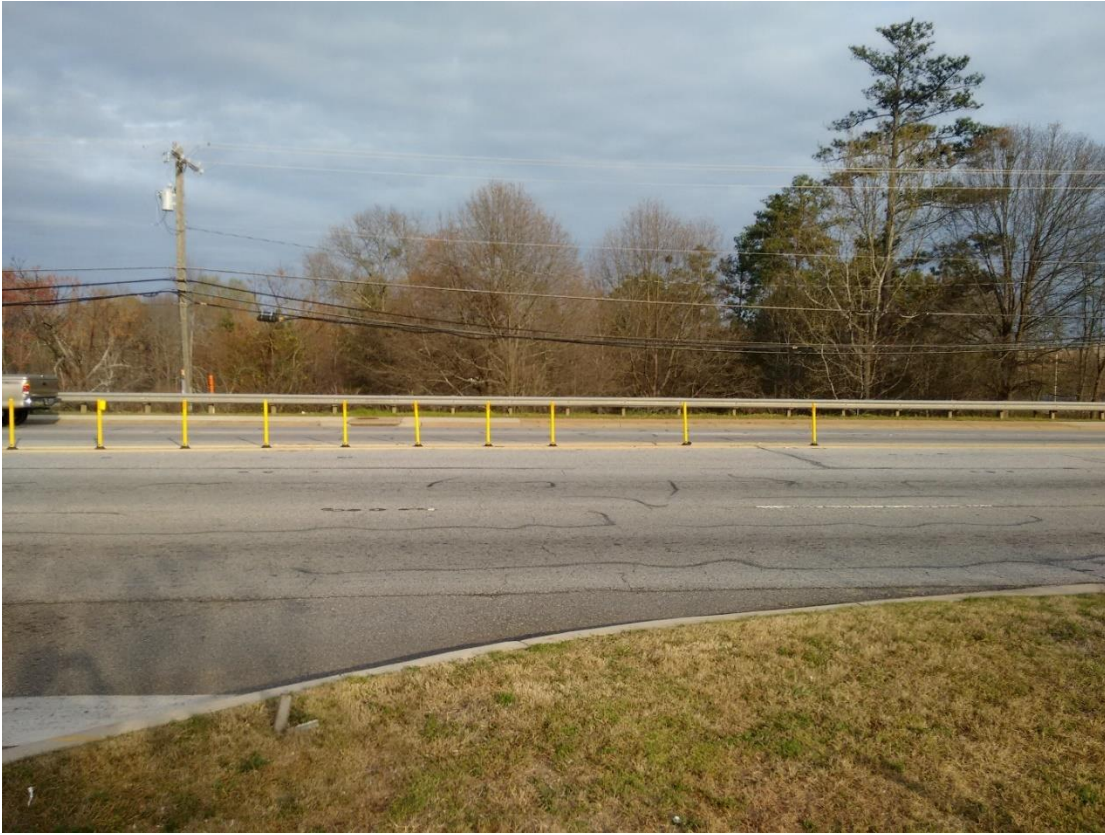
**Figure 3.15: RIRO Bollards as on March 24, 2017**

It is also worth noting that the longitudinal delineating bollards, while effective in working as channelization devices, are prone to be knocked off. Figure 3.15 shows that some of the bollards towards the right end were knocked off at the driveway as of March 24<sup>th</sup>, 2017.

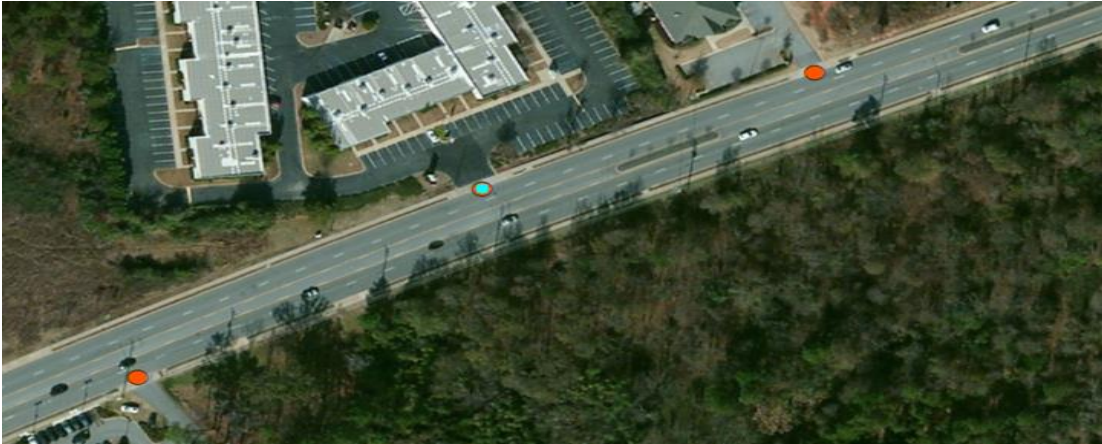
**Figure 4.2: A FA Driveway (Top) and Attributes Associated (Bottom)**

<b>FID</b>	3484	<b>D_Type</b>	3
<b>FID_1</b>	3484	<b>Aux_Lane_R</b>	1
<b>Join_Count</b>	1	<b>Med_Type</b>	4
<b>TARGET_FID</b>	7	<b>Parking_Ty</b>	1
<b>POINT_X</b>	0	<b>D_Use</b>	2
<b>POINT_Y</b>	0	<b>D_Class</b>	4
<b>NEAR_X</b>	0	<b>D_Use_Size</b>	4
<b>NEAR_Y</b>	0	<b>Sh_Use</b>	2
<b>Id</b>	0	<b>No_D_Use</b>	1
<b>Segment_No</b>	0	<b>D_Hierarch</b>	3
<b>Driveway_N</b>	13	<b>D_Control</b>	1
<b>Seg_Dr_No</b>	0	<b>D_Control_Binary</b>	0
<b>D_Spacing</b>	542	<b>DWidth_P15</b>	34
<b>D_Radius</b>	20	<b>Shape_Leng</b>	63.12232808
<b>D_Width</b>	39	<b>BUFF_DIST</b>	34
<b>N_Entry_Ln</b>	1	<b>Corridor</b>	SC146Greenville
<b>N_Exit_Ln</b>	1	<b>Student</b>	Xi
<b>D_Angle</b>	1	<b>Check</b>	0
<b>D_Corner_C</b>	0	<b>AADT</b>	12100
<b>D_Throat</b>	45	<b>SpeedLimit</b>	45
<b>Sight_Dist</b>	1	<b>FAorRIRO</b>	FullAccess

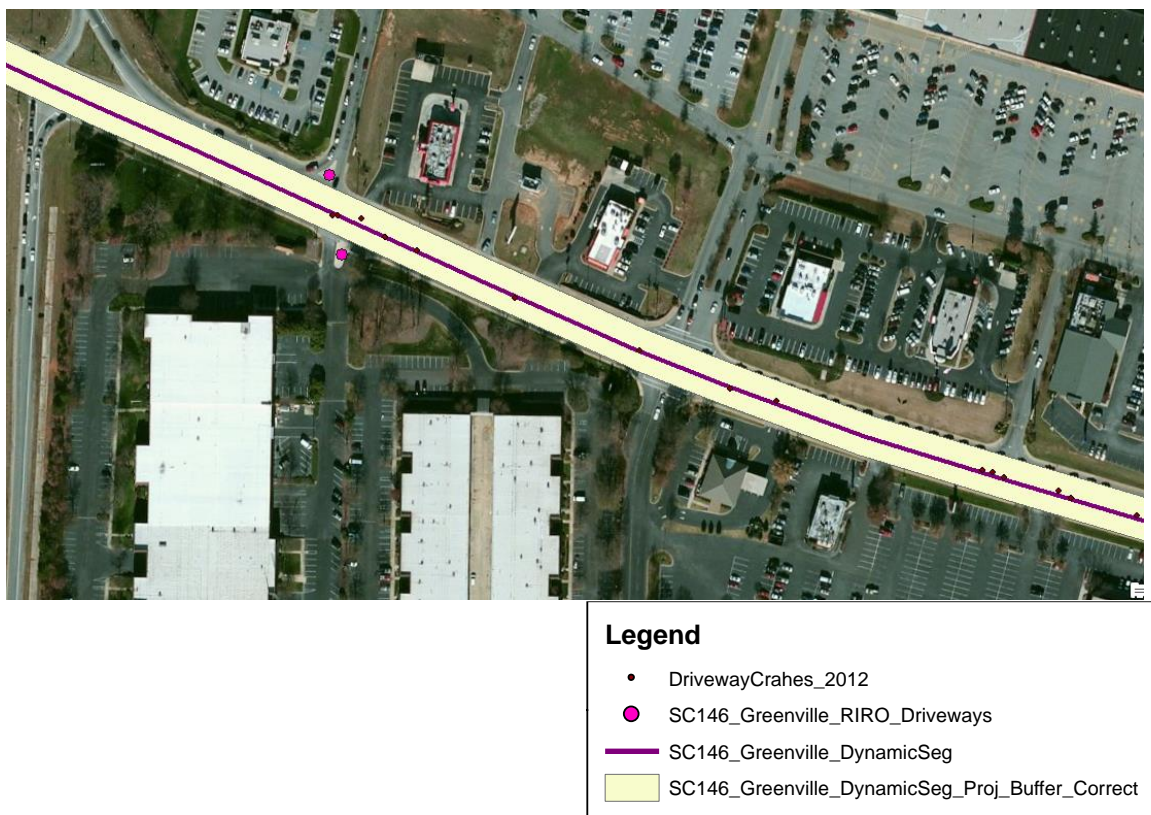
**Figure 4.3: Travelway Buffer**

Figure 4.3 shows the travelway buffer for a section of SC 146 along Greenville, SC., which includes the centerline along with driveway points and crash locations (for 2012) depicted as point shape files in ArcGIS. Additionally, the legend depicts the names of the layers used for the travelway buffer creation in ArcGIS.

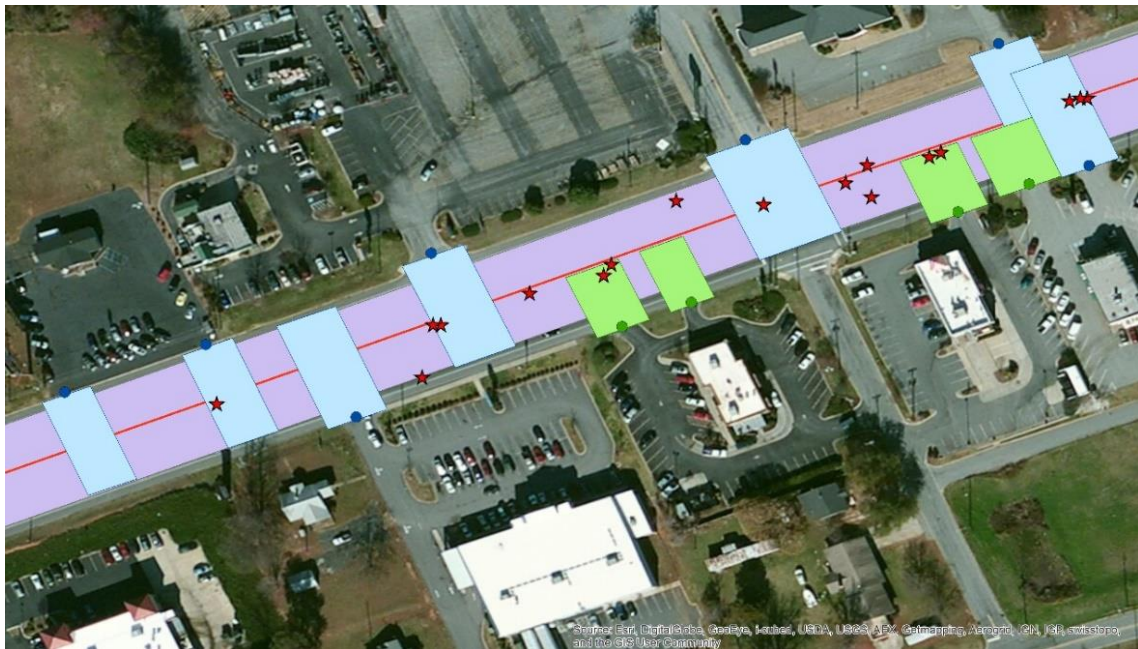
**Figure 4.5: Full-access and RIRO driveway buffers**

Upon creating the travelway buffers, driveway buffers were created, to represent their influence area from a crash standpoint. One problem with standard circular buffering based on location of the driveway access point is that it would bias toward crashes that occur closer to the edge of the road (near the driveway entrance). Ideally, rectangular buffers would provide a better indicator of a driveway's influence area. Thus, a model was created that could make rectangular buffers that stretched across the roadway as shown in Figure 4.5.

Two models were created depending on driveway type: a model for full access driveways that creates buffers extending across all travel lanes; and a model for right-in-right-out (RIRO) driveways that creates buffers that extend to the roadway centerline.
